1 Fire among the major risks of cultural heritage

2 Methodological approach and case study

This paper deals with an emblematic case of interface fire occurred in Lambayeque region, in Northern Peru (fig. 2), on November 12, 2017, which devastated Huaca-Ventarron, including a mural painting believed to be the oldest discovered in the Americas (CNN 2017) .

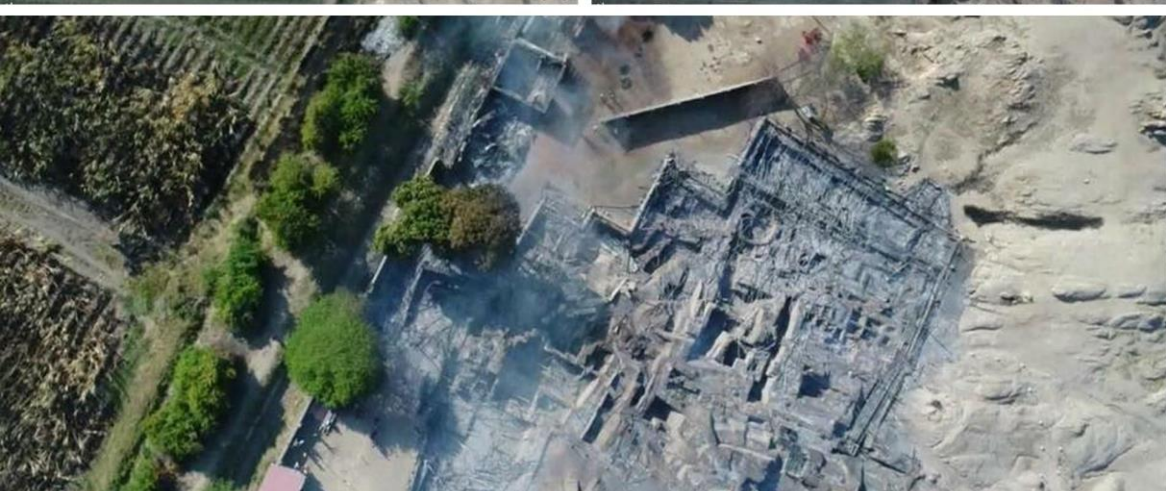
Fig.5 (a-d) Satellite multitemporal data set; (e) aerial image taken from drone (courtesy by Ignacio Alva)

Remote and proximal sensing tools, from satellite data to images acquired from drones, could help to identify responsibilities, destructive dynamics of the event, possible errors in the management of agricultural fields. With such regard, the multitemporal data set (figure 5 a-d) available from Google Earth evidenced that before 2016 March (figure 5a-b), the area where the fire started, was not cultivated and characterized by sparse herbaceous cover, with a (conscious or unaware?) function of firebreak. From March 2016 up the fire event the plot of land adjacent the archaeological site was covered by cultivations (figure 5c), eliminating the fire cut function that probably would have made the fire less destructive.

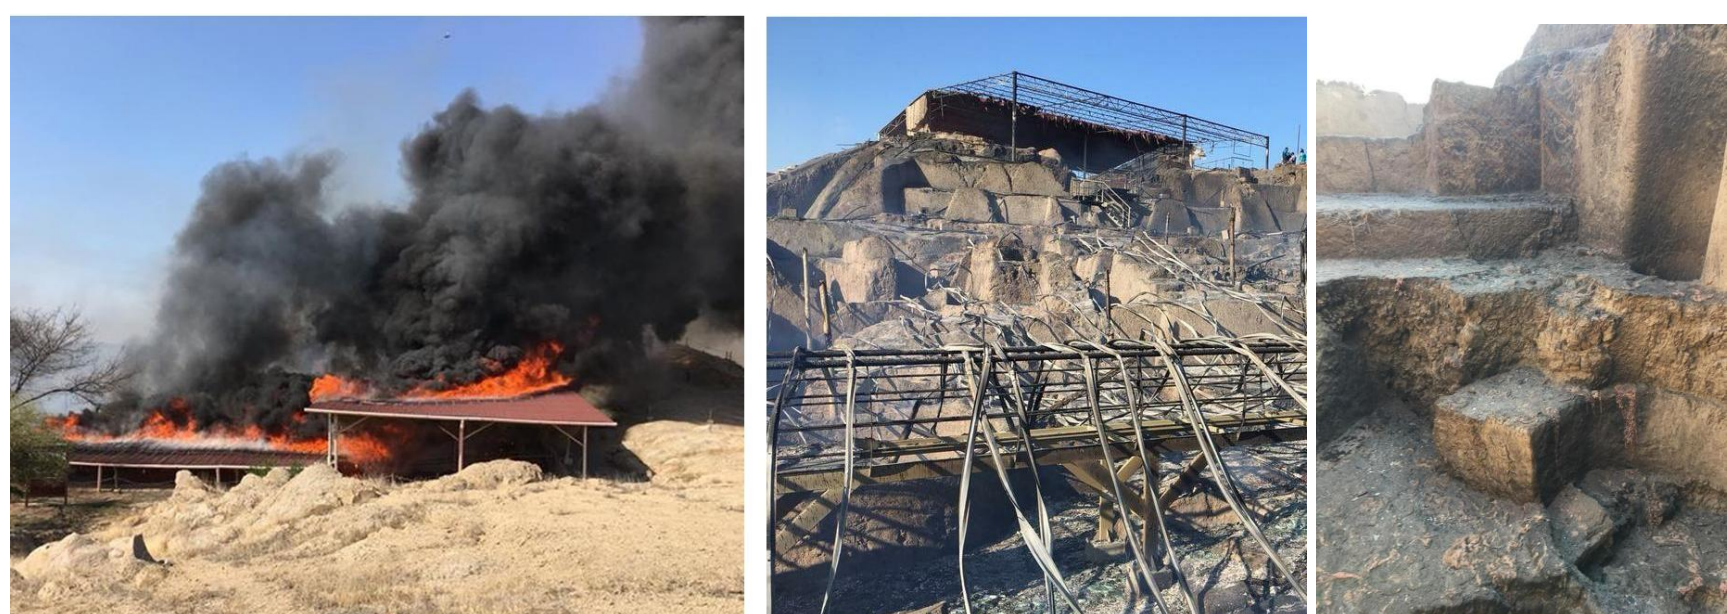
Fig.6 (Sx) Roof of the monument on fire (courtesy by Ignacio Alva); (medium and right) Damage caused by the fire (courtesy by Ignacio Alva)

Ground documentation, drone flights and satellite acquisitions showed that the fire was caused by the burning of weeds of a sugar company in the contour of the fields, adjacent to the archaeological monument. The fire began as part of the regular work of burning fields. It was also found that the burning of weeds was not controlled and spread for more than 200 meters in favor of the wind. The fire in its uncontrolled route reached the roofs of the warehouses located on the west side of the archaeological site. Immediately afterwards, the fire spread rapidly and became uncontrollable due to the flammable nature of the material used on the roof covering the archaeological structures (bituminous tablet, Onduline, plastic plates of Fibraforte). In particular plastic material, once burned, melted on the most important murals and architectural components, with heavy damage to pictorial layers and walls. The Peruvian Ministry of Culture announced an official investigation to determine who was responsible for the fire.
